**Subject: THIRD Complaint** – Public Safety, Runoff, and Critical Areas Concerns Related to Retaining Wall Above City Nature Trail (Near 3311 S 2nd Way)

This letter serves as my third formal complaint notice regarding the retaining wall, shed/chicken coop, slope excavation, and disturbed earth at or near 3311 S 2nd Way, Ridgefield, WA, located directly above the city-owned nature trail behind our properties.

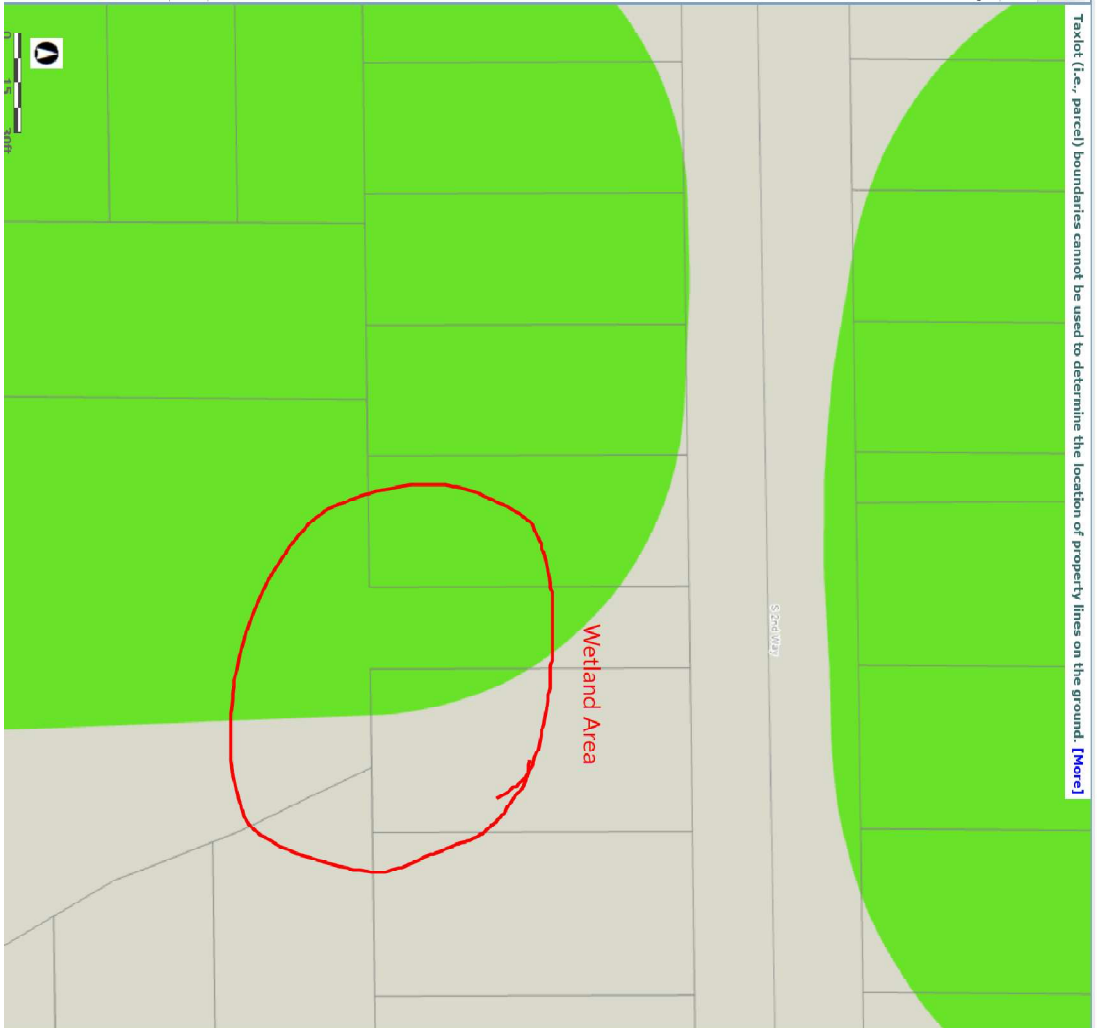
Based on Clark County GIS references and local maps, the slope and greenbelt behind our homes appear to lie within or adjacent to a Riparian Habitat or Critical Areas buffer.

- ☐ Environmental
  - ☒ Land Records
    - ☒ Building Footprints
    - ☒ Taxlots
  - ☐ Public Land Survey System
  - ☒ Environmental
    - ☒ Endangered Species Act

- ☐ Fish Barriers
    - ☒ Fish Species of State Concern
    - ☒ Environmental Constraints
      - ☒ Components of Environmental Constraints Group
        - ☒ Active or historic unstable slope

- ☒ Floodway or floodway fringe
        - ☒ Hydric Soil - buffered to 50 ft
        - ☒ Priority Habitats and Species - Non-Sensitive Only
        - ☒ Shoreline designation

- ☒ Steep Slope
        - ☒ Wetland Inventory - buffered to 100 ft
- ☐ Floodplain
- ☐ Geology
- ☐ Elevation
- ☒ Priority Habitats and Species Group
  - ☒ Species

- ☒ Habitat
  - ☒ Potential Riparian Area
  - ☒ Riparian Habitat Site Class
  - ☒ Location generalized due to sensitivity
- ☒ Slopes and Geologic Hazards Group
