Date: November 18th, 2025

Re: Formal Unified Complaint – Retaining Wall Violations, Surcharge Hazards, Unauthorized Excavation, Encroachment, Trespass, and Failure of the City of Ridgefield to Enforce Required Codes

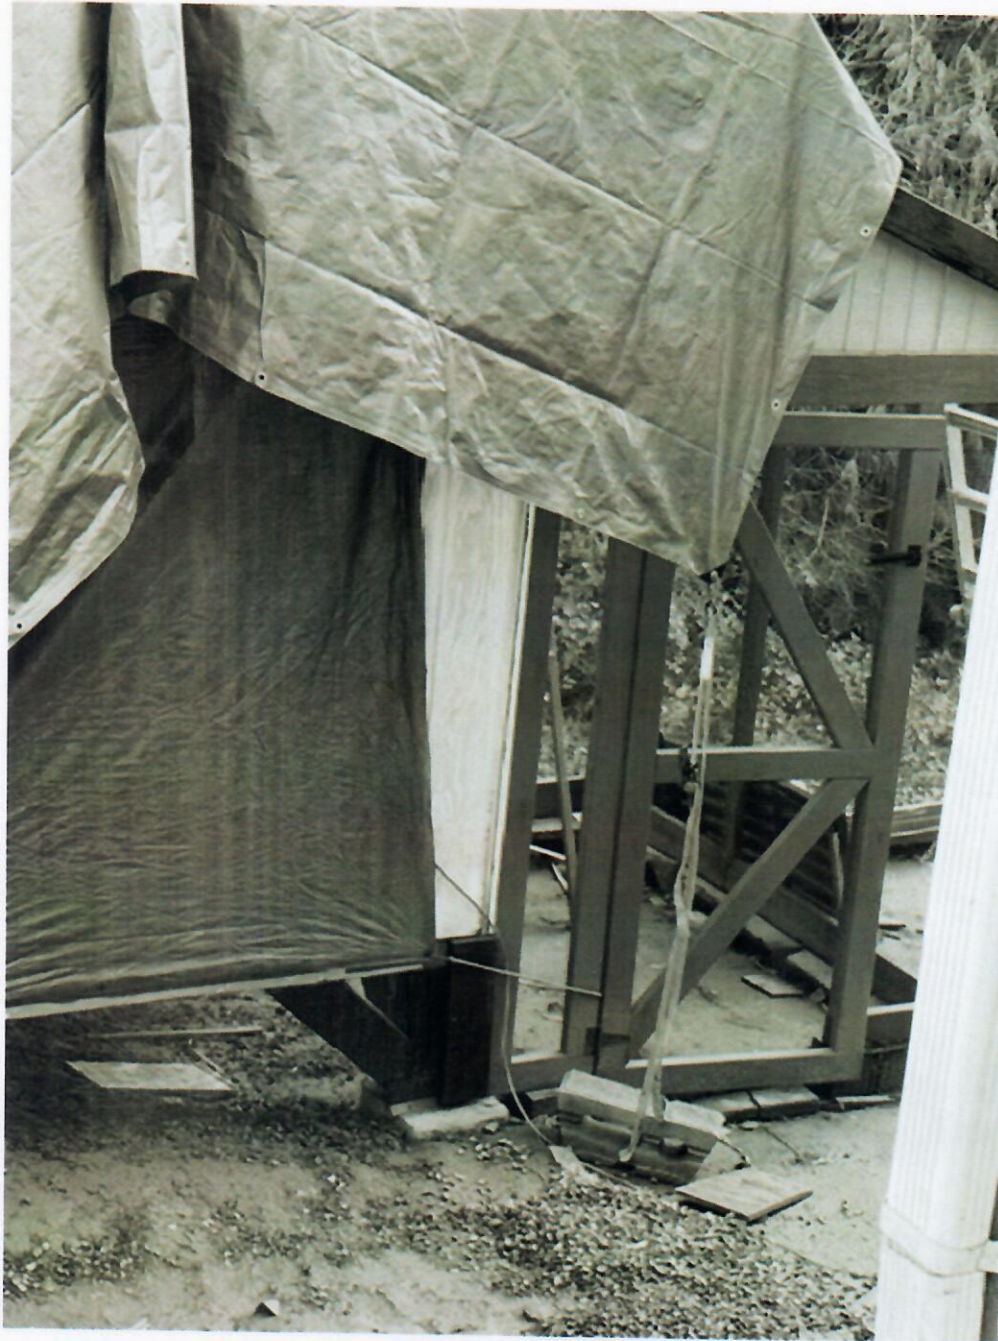
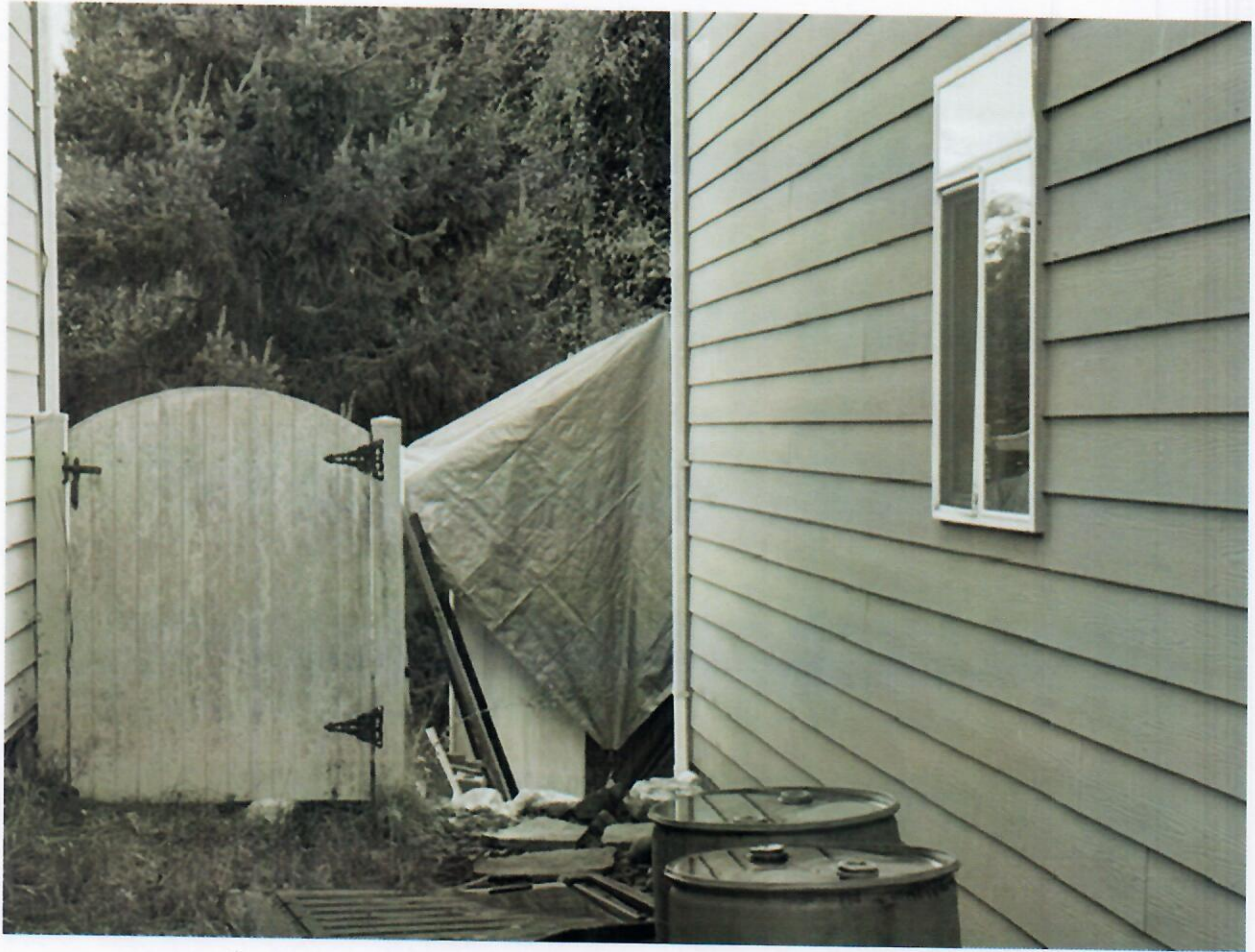
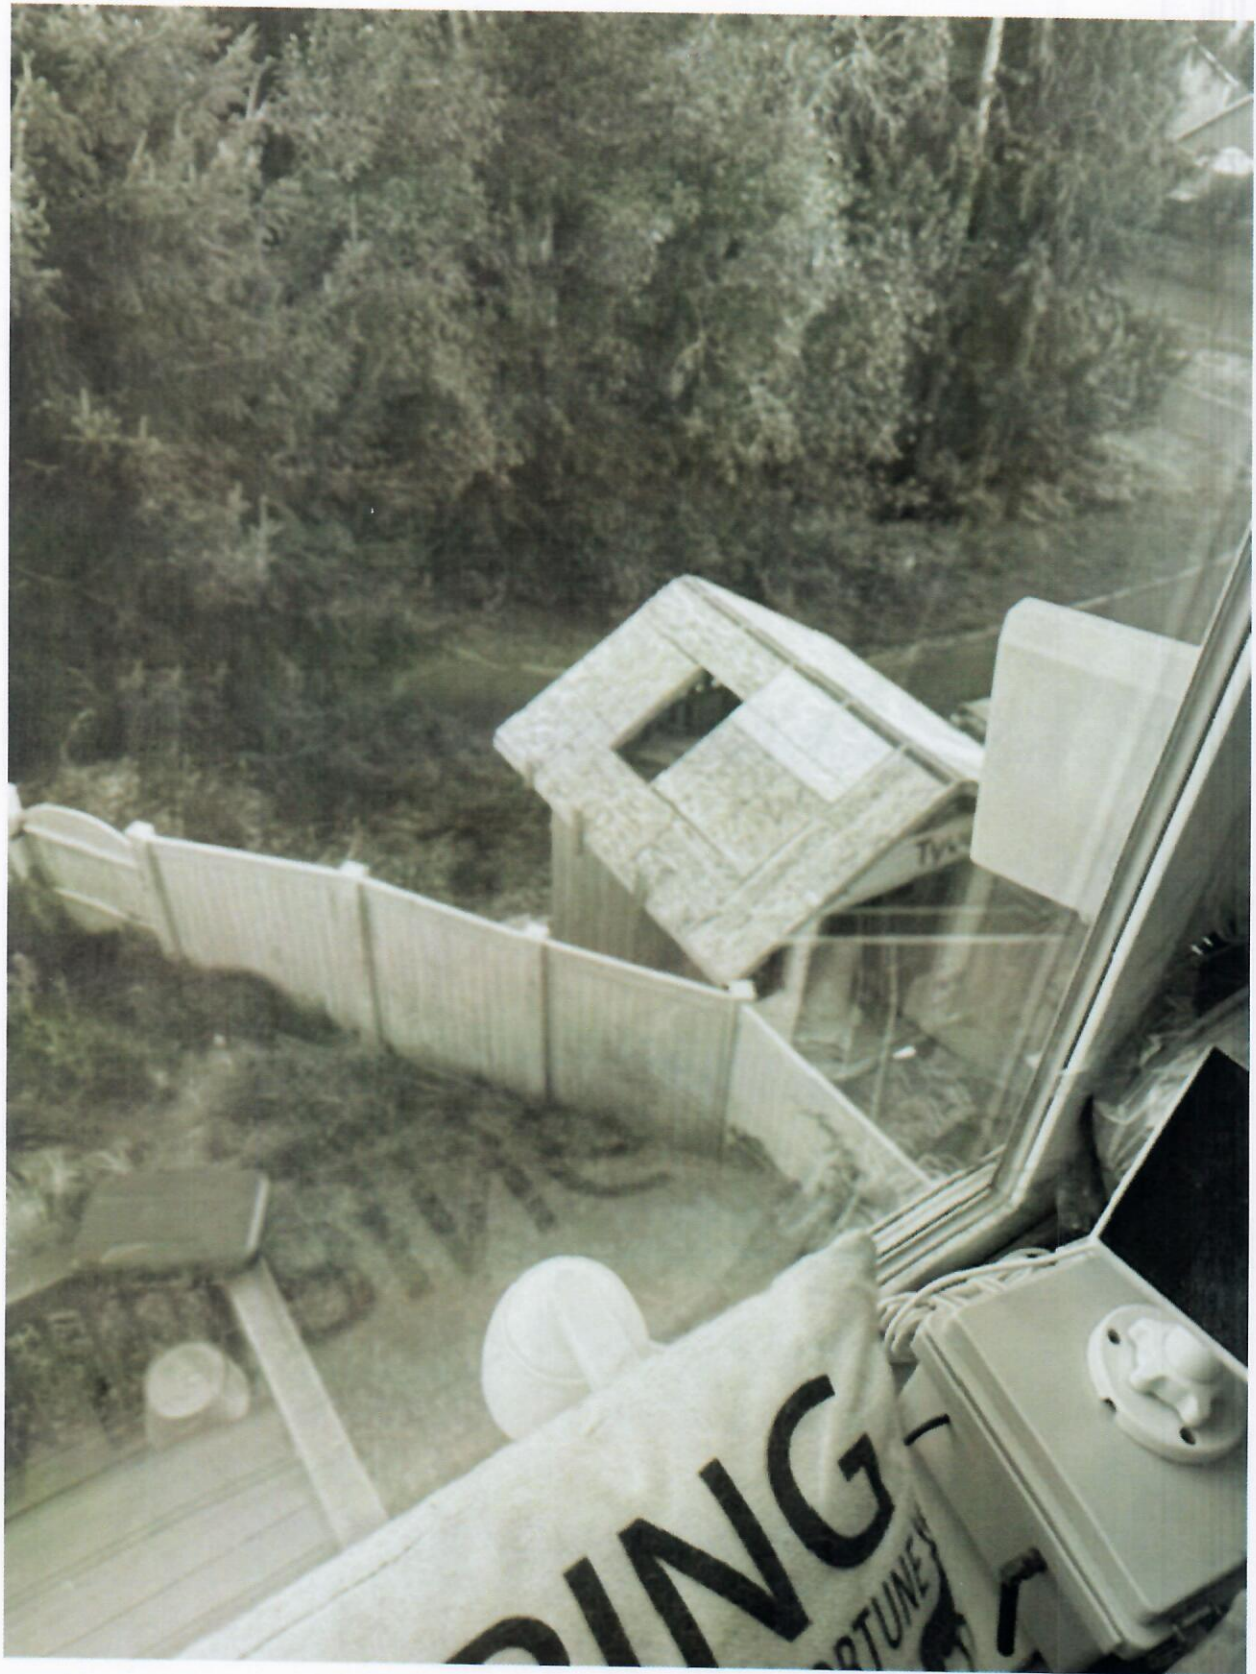
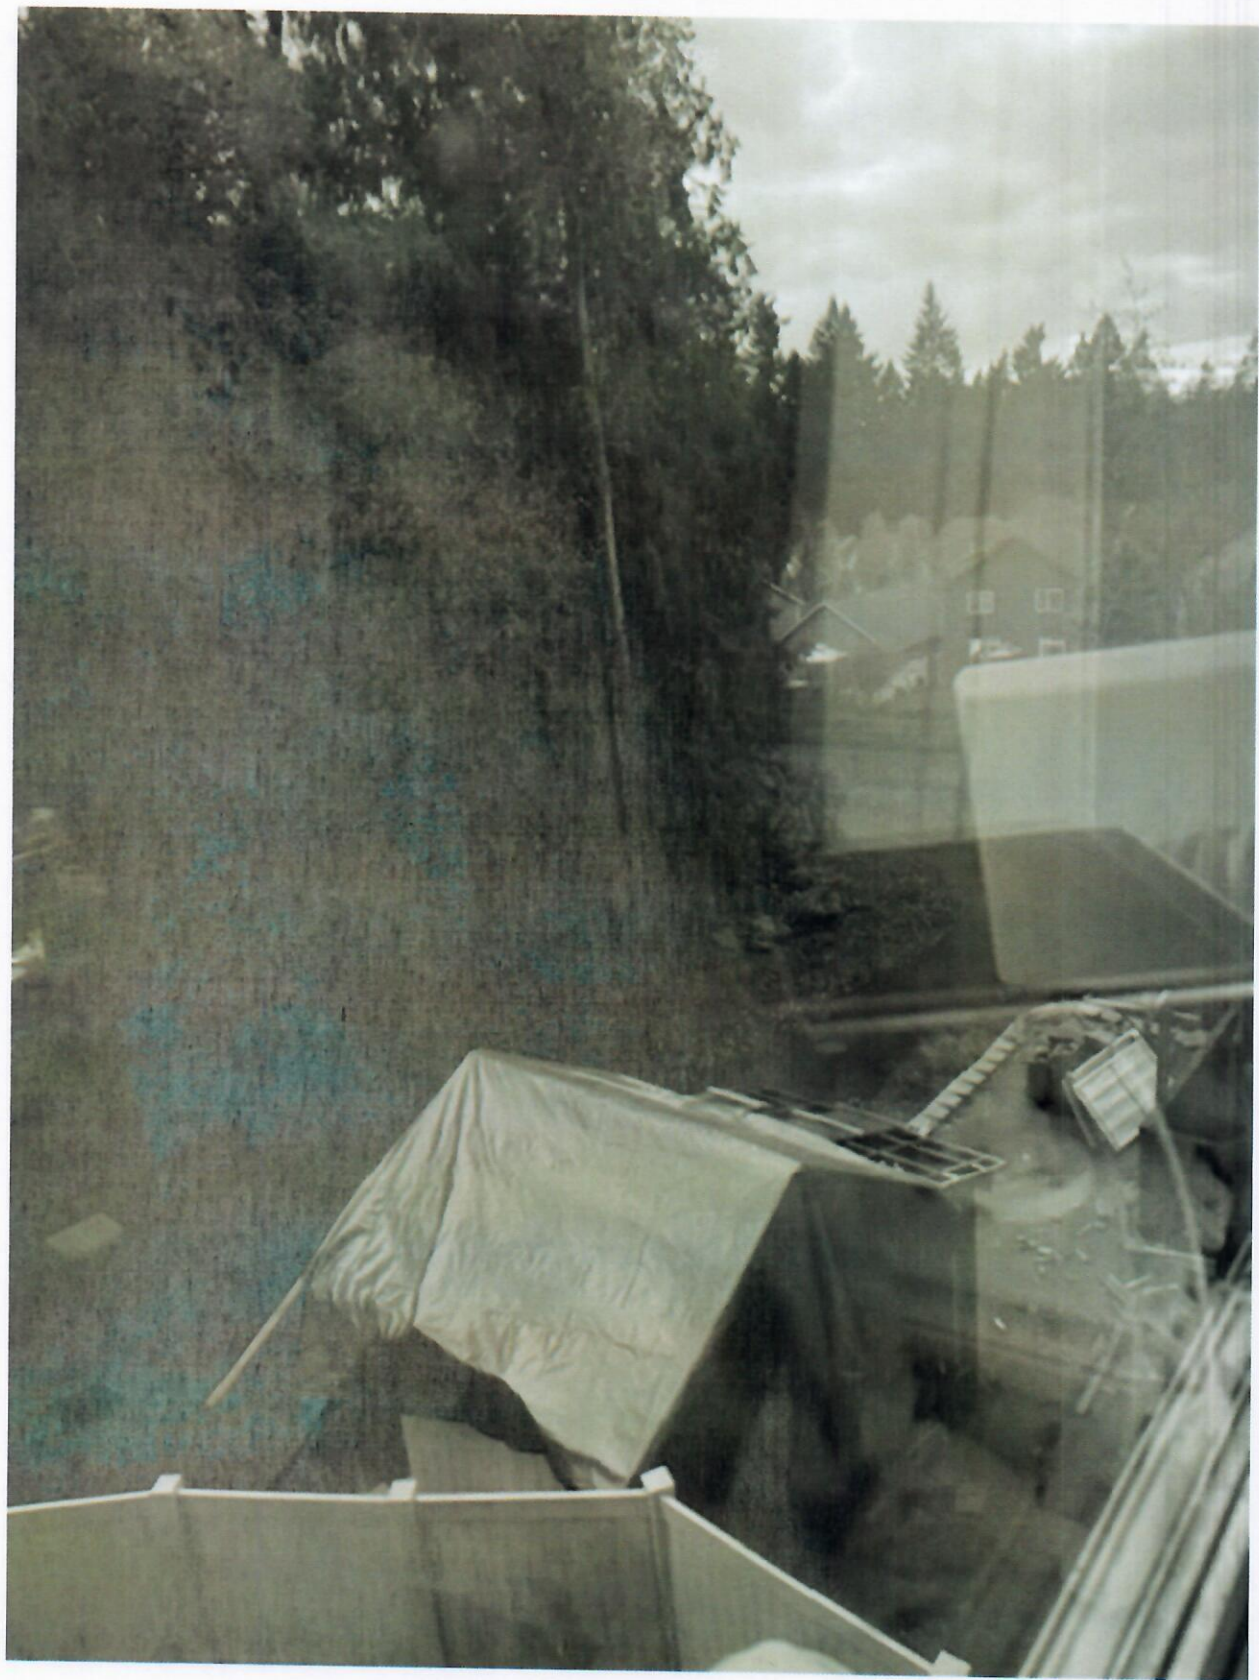
Today I discovered **new violations**, including unauthorized excavation up to my fence, unpermitted block material leaning against my soil, and construction materials stored on my fence—constituting trespass and structural tampering.

The neighbor added a shed containing thousands of pounds of materials directly above a retaining wall. This shed constitutes a **surcharge**, a load that significantly increases pressure on the wall.

A. Excavated soil directly up to my fence line

B. Placed loose block material leaning outward against my soil

C. Built over my fence and stored construction materials on my fence

These actions have **further destabilized the slope**, increased risk of collapse, and violated property boundaries.

1. **Emergency site inspection**

2. **Stop-work order** issued under CCC Title 14
3. **Verification of all required permits** (retaining wall and shed)
4. **Structural engineering assessment by a Washington-licensed engineer**
5. **Critical areas compliance review** under CCC 40.440
6. **Removal of all block material, soil restraints, and stored items from my fence**
7. **Restoration of the excavated area** to pre-disturbance conditions
8. **Written findings within 48 hours**

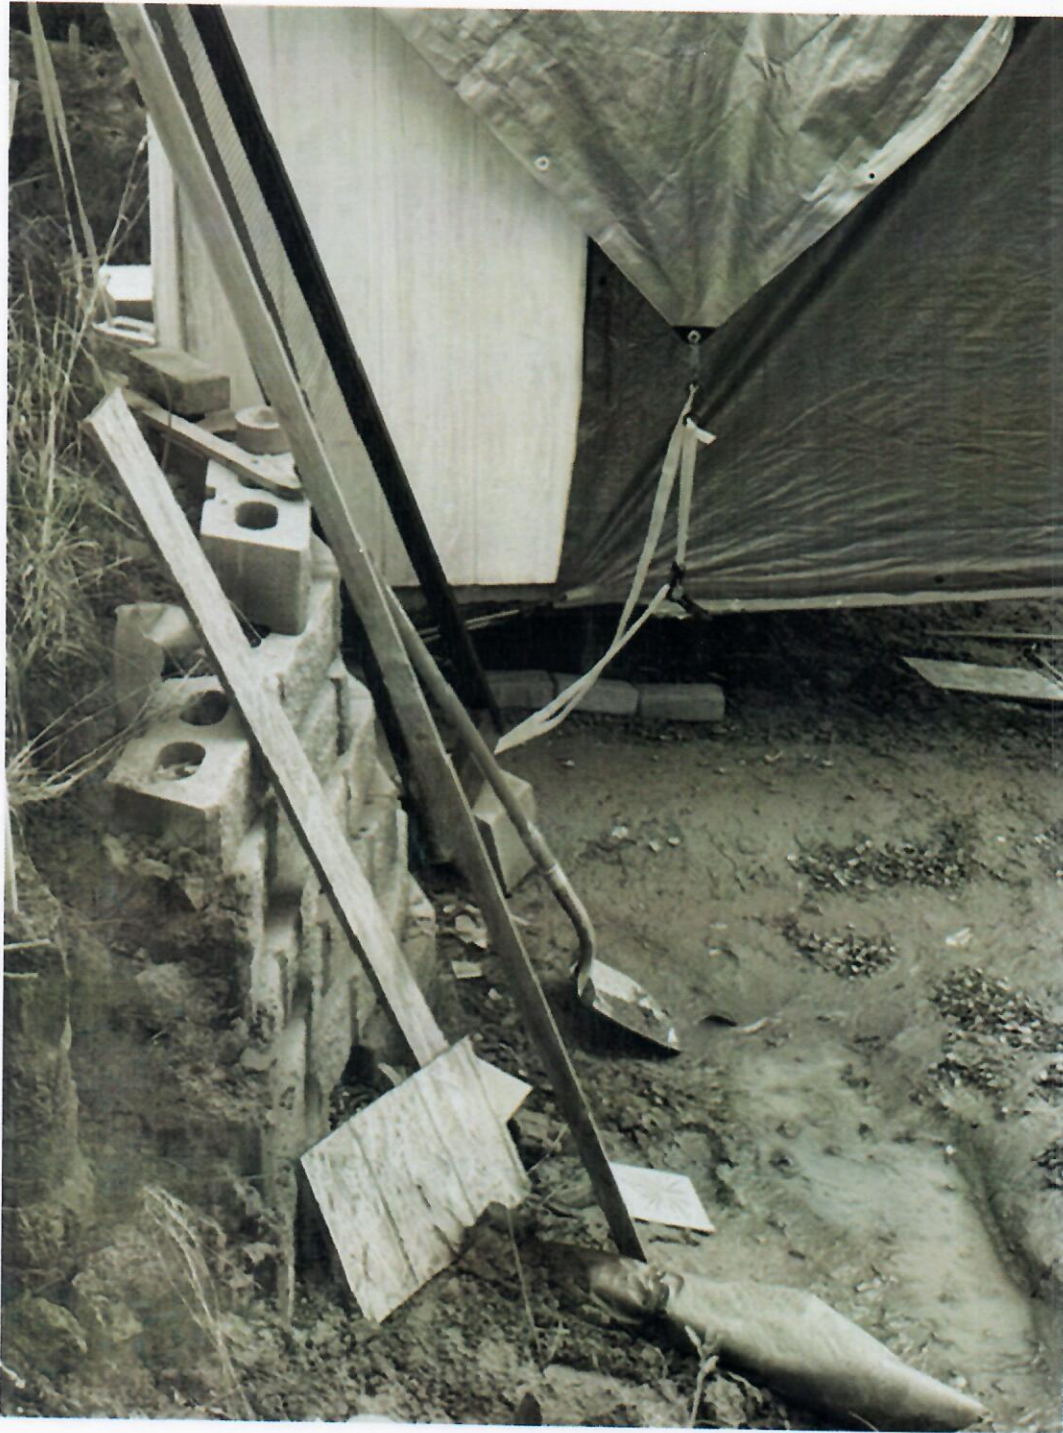
My property / Fence held back by this wall. My backyard is to the left.
